THE EFFECT OF EROSION IN RURAL AREA AND RECOMMENDATIONS FOR DIMINISHING THE NEGATIVE CONSEQUENCES

Olesea Cojocaru

State Agrarian University of Moldova

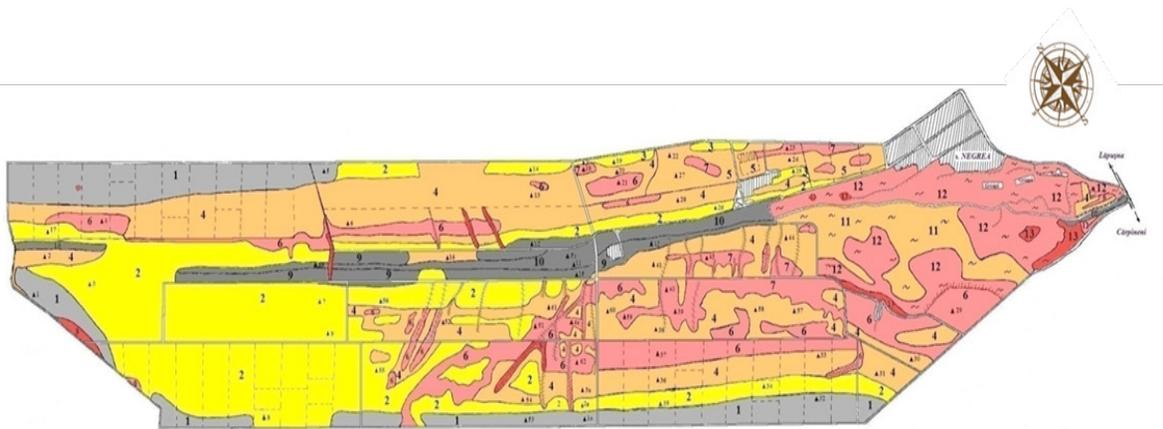
Fig. 1. Map of soils in the village Negrea, research scale 1:5000, in 2014.

According to legend of the soil map (Fig. 1), the diversity of soil units in territory of village Negrea, is formed mainly from soils with different degrees of erosion (Tab. No.1).

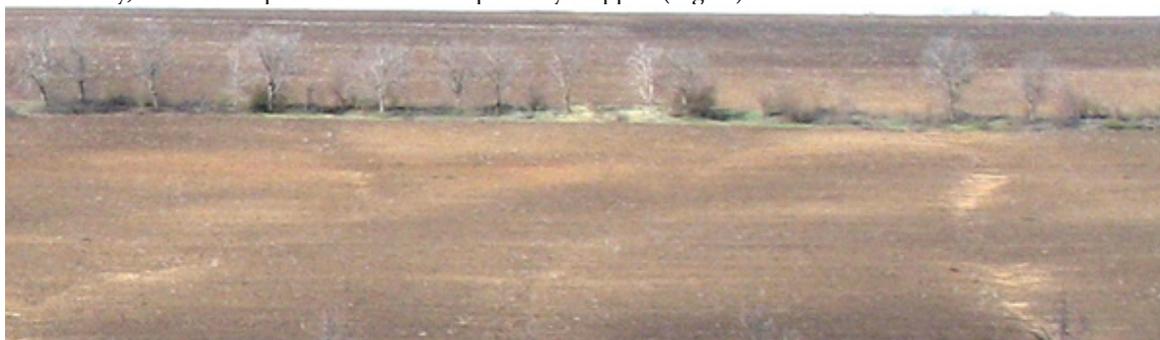
Fig.2. Orchard on the micro-terrace slope

The pedological research showed that in the areas of the village Negrea (Cojocaru, 2015) that were used in the past completely under orchards and vineyards located on micro-terrace slopes and correctly organized territorially, the erosion process of soils was partially stopped (Fig. 2.).

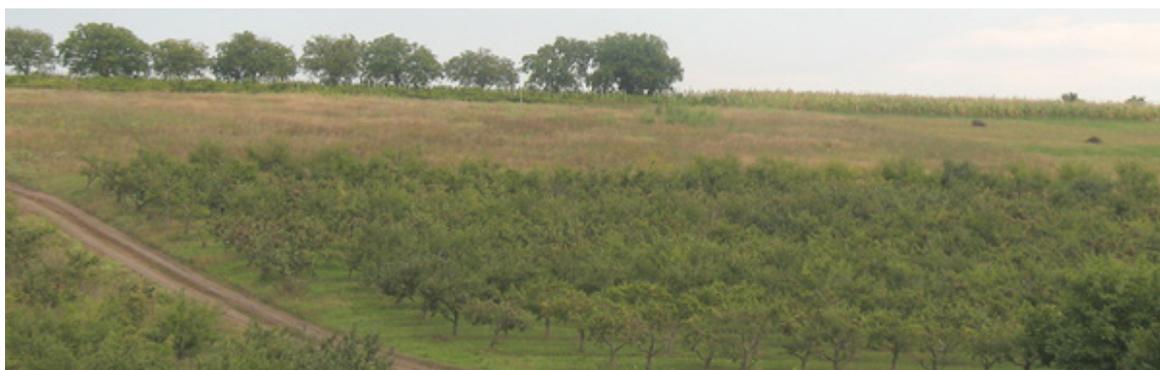
Fig. 3. The manifestation of erosion process on slopes after the deforestation of perennial plantations and levelling the micro-terraces

Currently the perennial plantings are largely deforested and the lands are planted with annual crops and used for arable farming, fact that leads to the intensification of the erosion processes (Fig. 3).
